Application No. R-75398
Permit No.

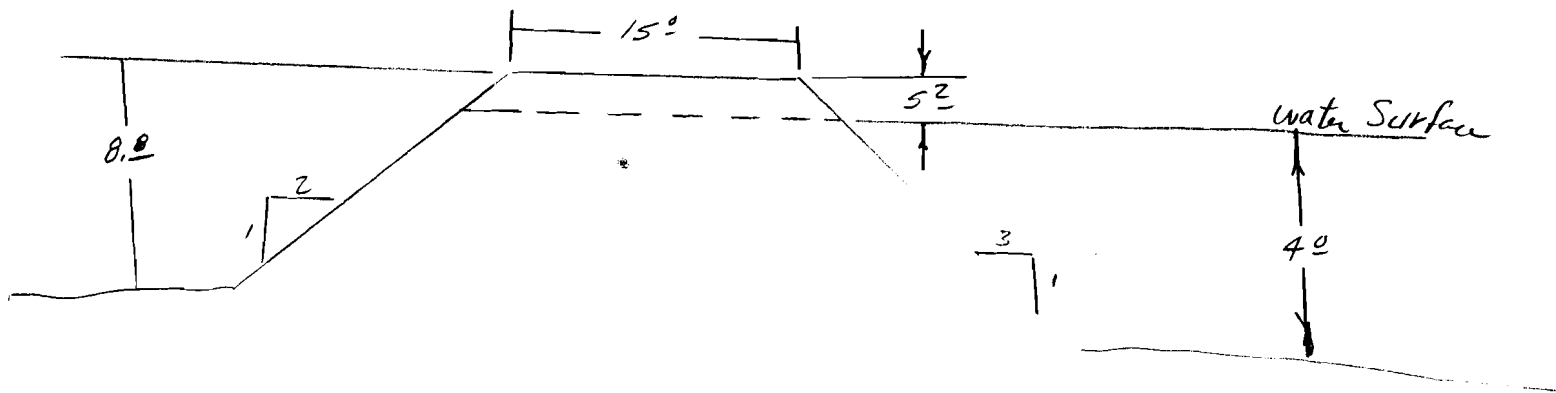
POND # 3

Surface Area 13,744

No existing spillway
Spring fed

$$\frac{13,744 \times 4 \times .4}{43,560} = .50 \text{ Ac Ft}$$

There is no existing spillway on this structure. The pond appears to be a hole dug to clean out a spring. There appears to be some water caught from runoff and snow melt. There is no indication that this pond has overflowed, as there is no evidence of erosion.

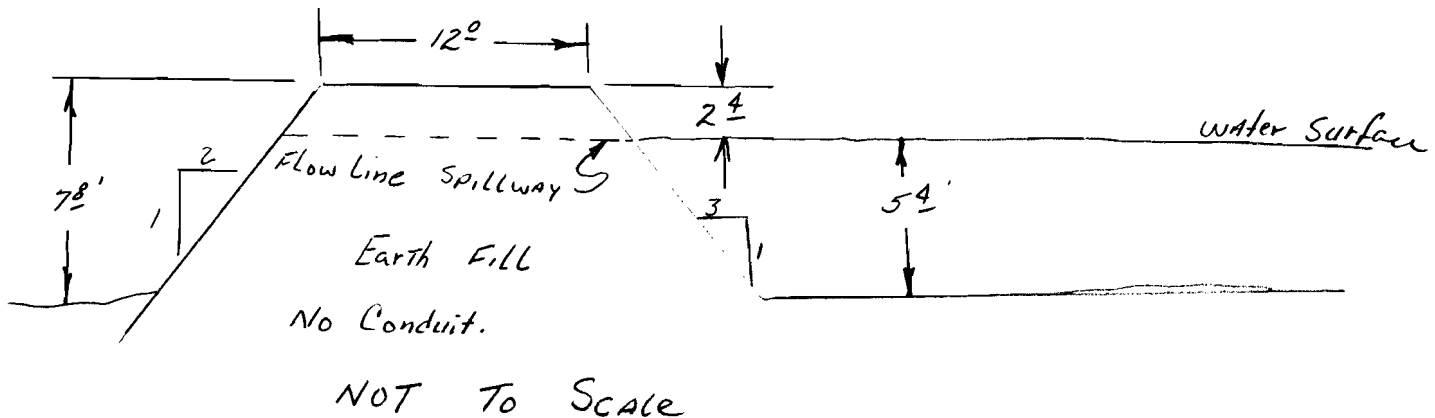
POND # 4

Pond Surface Area 43,000 Sq. Ft.

$$\frac{43,000 \times 5.4 \times .40}{43,560} = 2.13 \text{ Ac. Ft.}$$

The spillway is a dozed channel around the northerly end of the dam, and is of earth construction. The spillway is 6 feet wide and is 2.4 feet below the top of the dam. The pond is dug out of the ground, and the dam is constructed of the spoils taken out of the pond area. The pond is filled by snow melt and runoff.

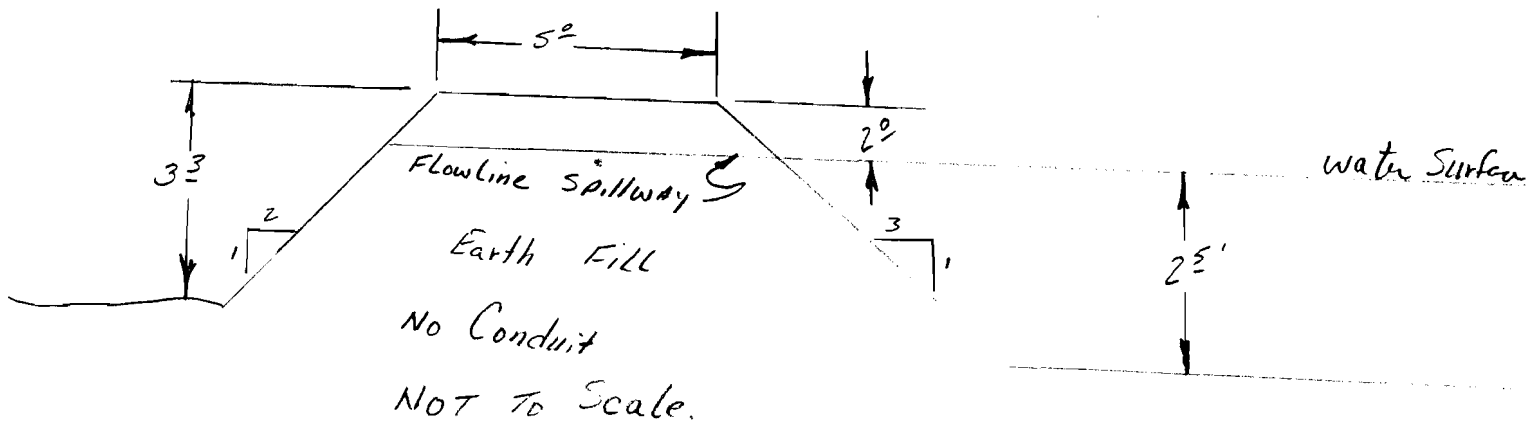
POND # 5

Pond Surface Area 16,600

$$\frac{16,600 \times 2.5 \times .40}{43,560} = .38 \text{ Ac. Ft}$$

The spillway is a dozed channel around the end of the dam, dozed out of the earth. The spillway is 3.5 feet in width, and is 1.2 feet deep. The Dam is constructed of earth taken from the pond. It appears that the water is mostly snow melt, possibly a spring fed pond. There is no stream feeding the pond.
