Water Resources Department

April 6, 2010

RE: Dam Inspection for Brown-Harland Reservoir; B-45

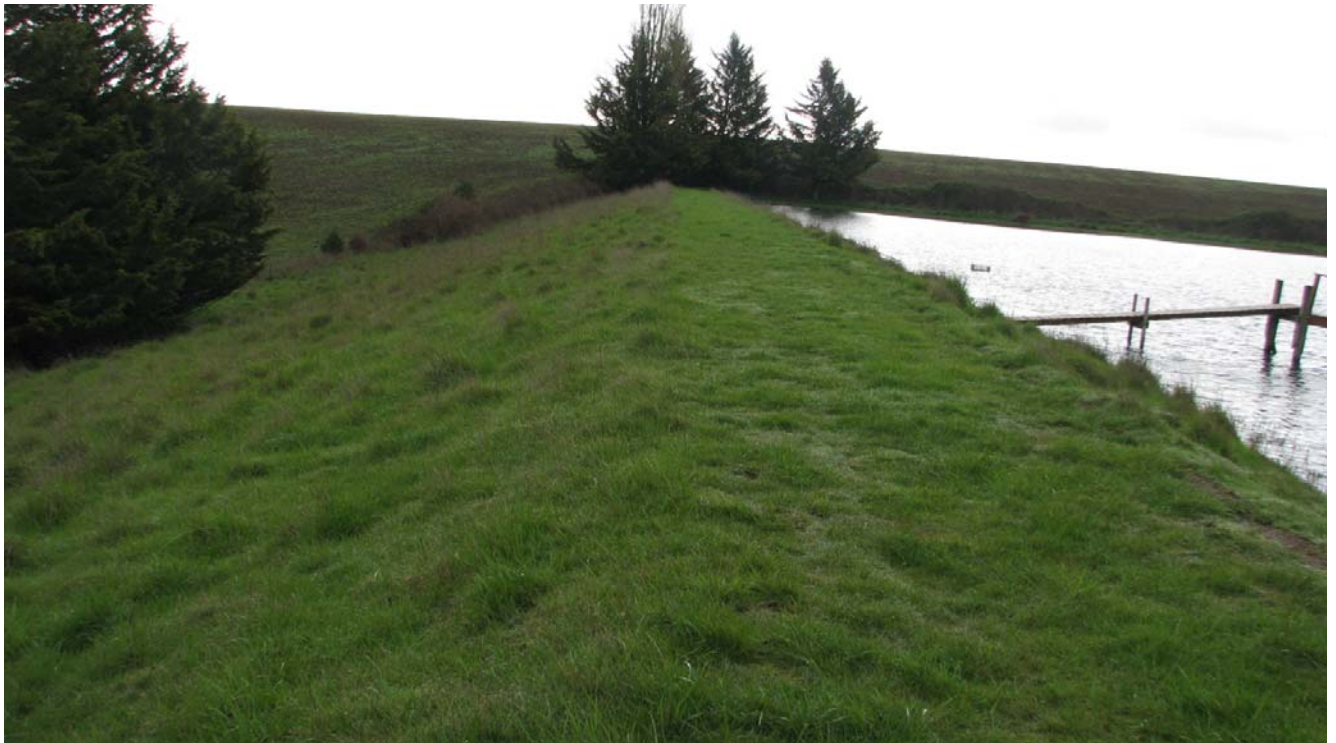
Figure 1. Upstream and downstream slopes and crest of dam showing the excellent control of woody vegetation on the dam.

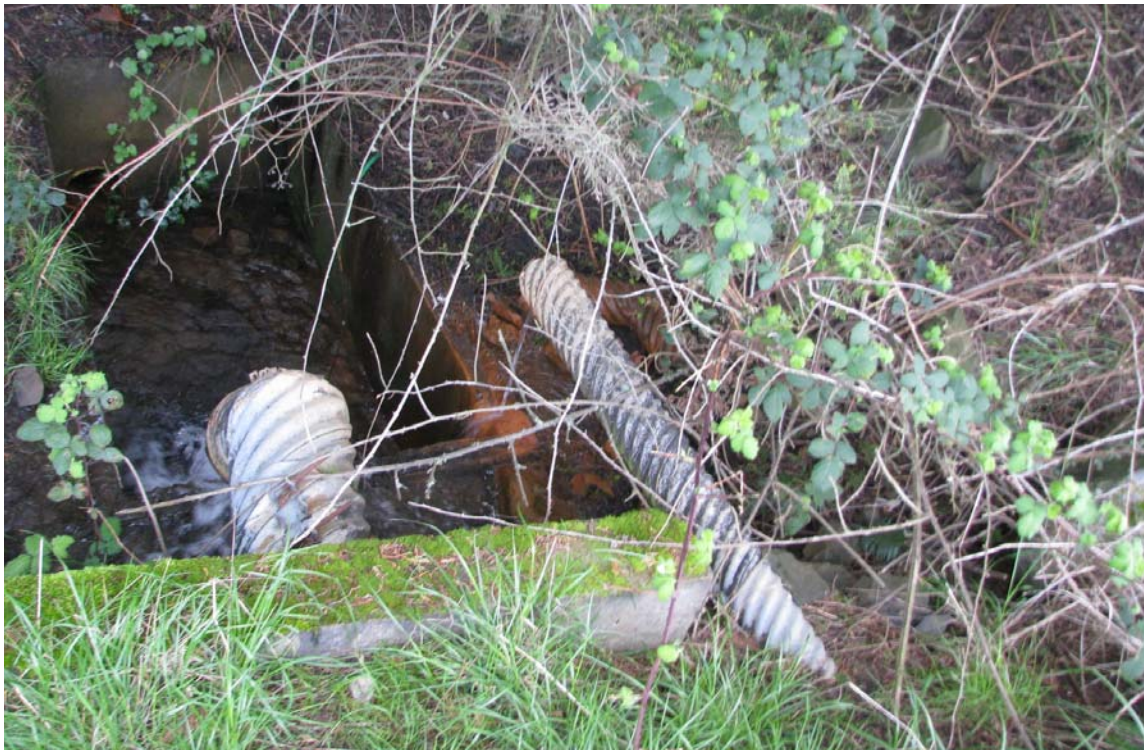
Figure 2. Outlet and toe drain that have some deterioration but are still in fair functional condition. The outlet conduit is not encased and may need to be lined in the next 10-20 years.

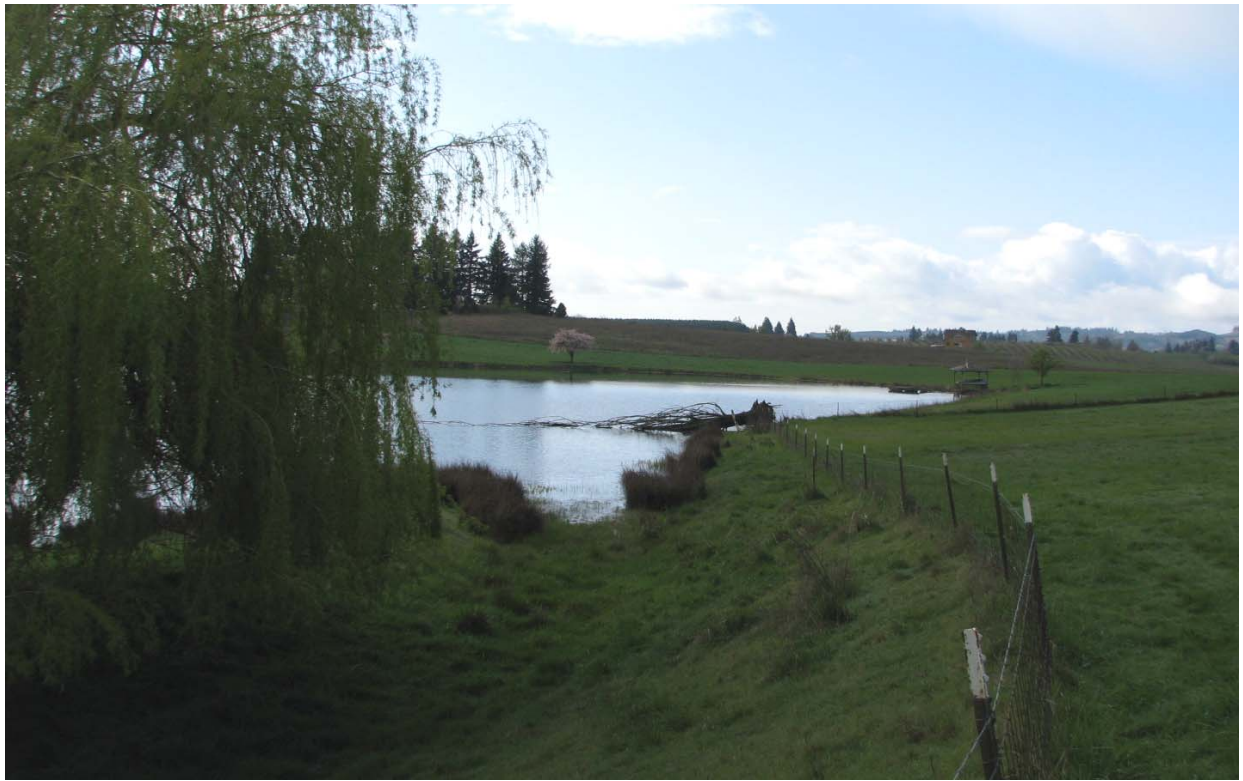
Figure 3. Entrance to the auxiliary spillway. From the lack of erosion and signs of water flow it is rare that water gets into this spillway.

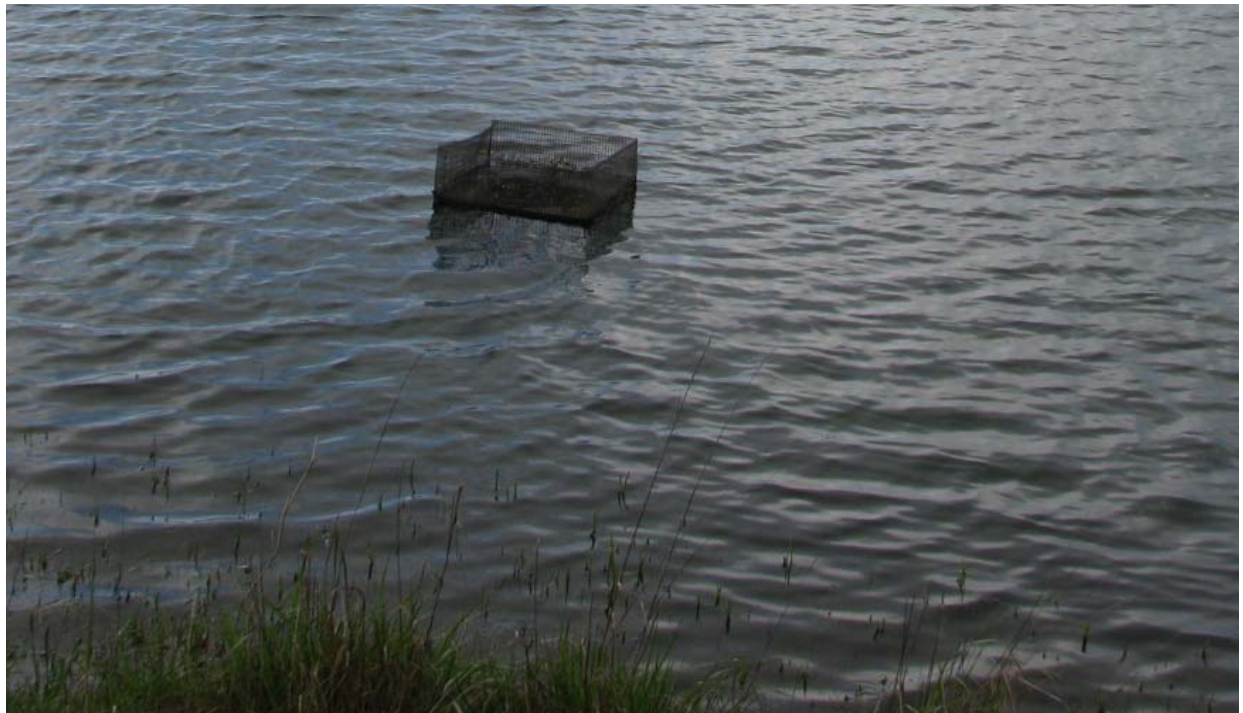
Figure 4. Trickle tube for outlet. The trash rack and general condition appear to be in fair to good condition and it was functioning the day of inspection.
