A Systematic Evaluation of Spillway Sizing for Existing High and Significant Hazard Dams in Oregon

E. George Robison, Ph.D, P.E., and Michael Craven,
SIT - Dam Safety Section: Oregon Water Resources Department, Salem, Oregon

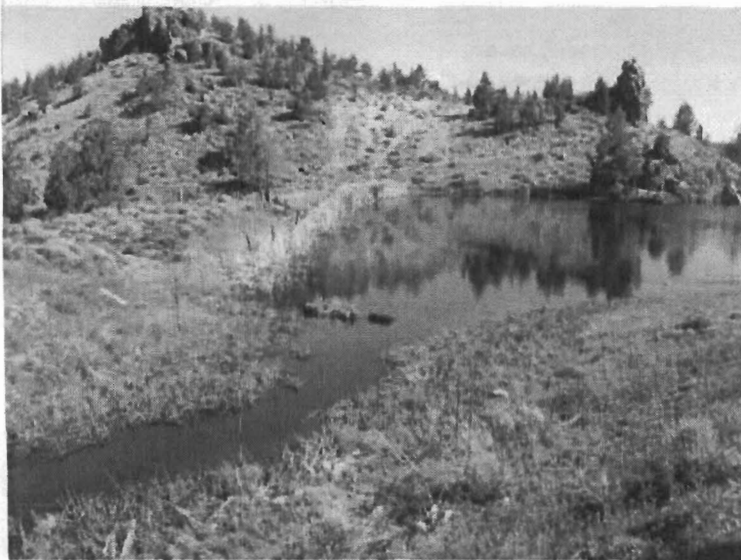
Spillway for Barnes Butte Dam

Each of these dams has a spillway capacity problem. In the winter of 2008-2009, Fishhawk Lake dam nearly overtopped during a large storm event. Barnes Butte shows evidence of down cutting in the spillway and erosion. For each of these dams, the long-term hydrologic record of nearby gages was examined to investigate wet and dry patterns in the record. The Log-Pearson III distribution (Interagency, 1982) was used to estimate the 100-year peak flow in increments and over the entire period, and these estimates were compared back to regional regression equations of Cooper (2005 and 2006).

this particular area due to the effects of volcano pumice and variable groundwater in the vicinity of this dam. From the severe erosion observed in the spillway during numerous field inspections, the spillway is under-sized.

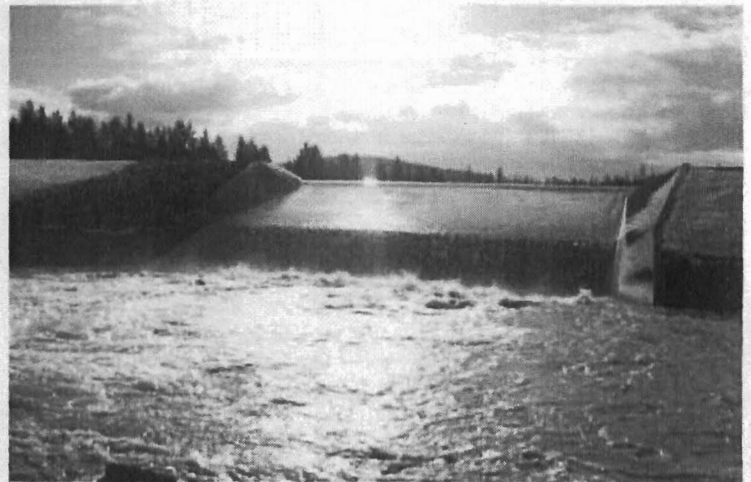
*Spillway at Mompano Dam
(a properly functioning spillway during a flood)*

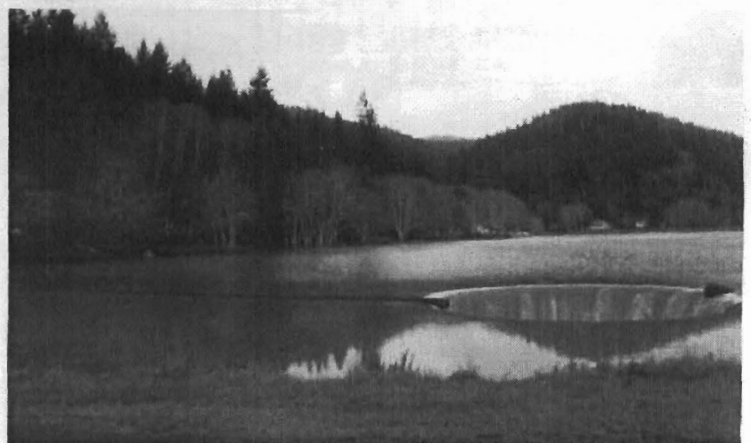
Drop Inlet Spillway for Fishhawk dam

Two dams, Fishhawk Lake and Barnes Butte Reservoir, were chosen to be evaluated in greater detail. Fishhawk Lake is located in Clatsop County in northwest Oregon. Total storage volume for this dam is 980 acre-feet with a tributary area of eighteen square miles. Fishhawk's spillway is a 41-foot-diameter drop inlet structure. Fishhawk dam had a significant hazard rating (Oregon Water Resources Department, and U.S. Army Corps of Engineers, 1981), which was recently upgraded to high hazard. Barnes Butte Reservoir is a high hazard dam located near the town of Prineville in central Oregon. The dam has a maximum height of 32.5 feet and a crest length of 400 feet. Total storage volume in the reservoir is 611 acre-feet with an upstream watershed area of four square miles. The spillway is an unlined trapezoidal channel with a base width of seven feet, side slopes of 3:1, and a depth of 3.1 feet.

Fishhawk dam's ratio of spillway capacity to 100-year flow of 1.3 was chosen as a threshold of concern because of its recent near overtopping problems. There were 13 dams with a ratio of spillway capacity to 100-year peak flow at or below 1.3, and nine were below a ratio of 1.0. Each of these dams has been flagged for further review.
