## WELL IDENTIFICATION APPLICATION FORM

Subject: HORNER WELL

## PLEASE ATTACH THIS EMAIL TO THE WIF FILED BY MIKE MCCORD ON JAN 28, 2002

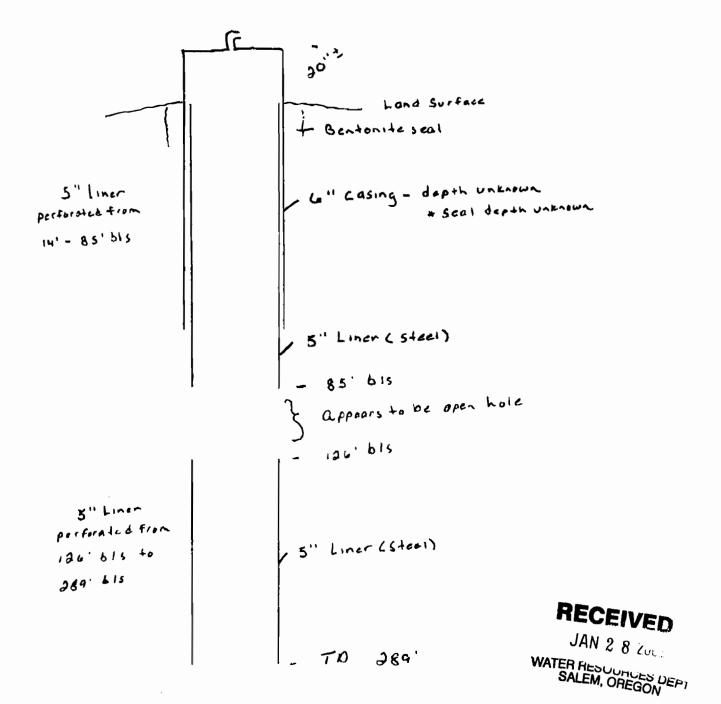
Not to scale
