# Hydrology & Water Storage Hurdles in Eastern Oregon

August 8, 2013 Presentation to  
OWRC

Developed and presented by Peggy S Browne  
Owner, Browne Consulting, LLC

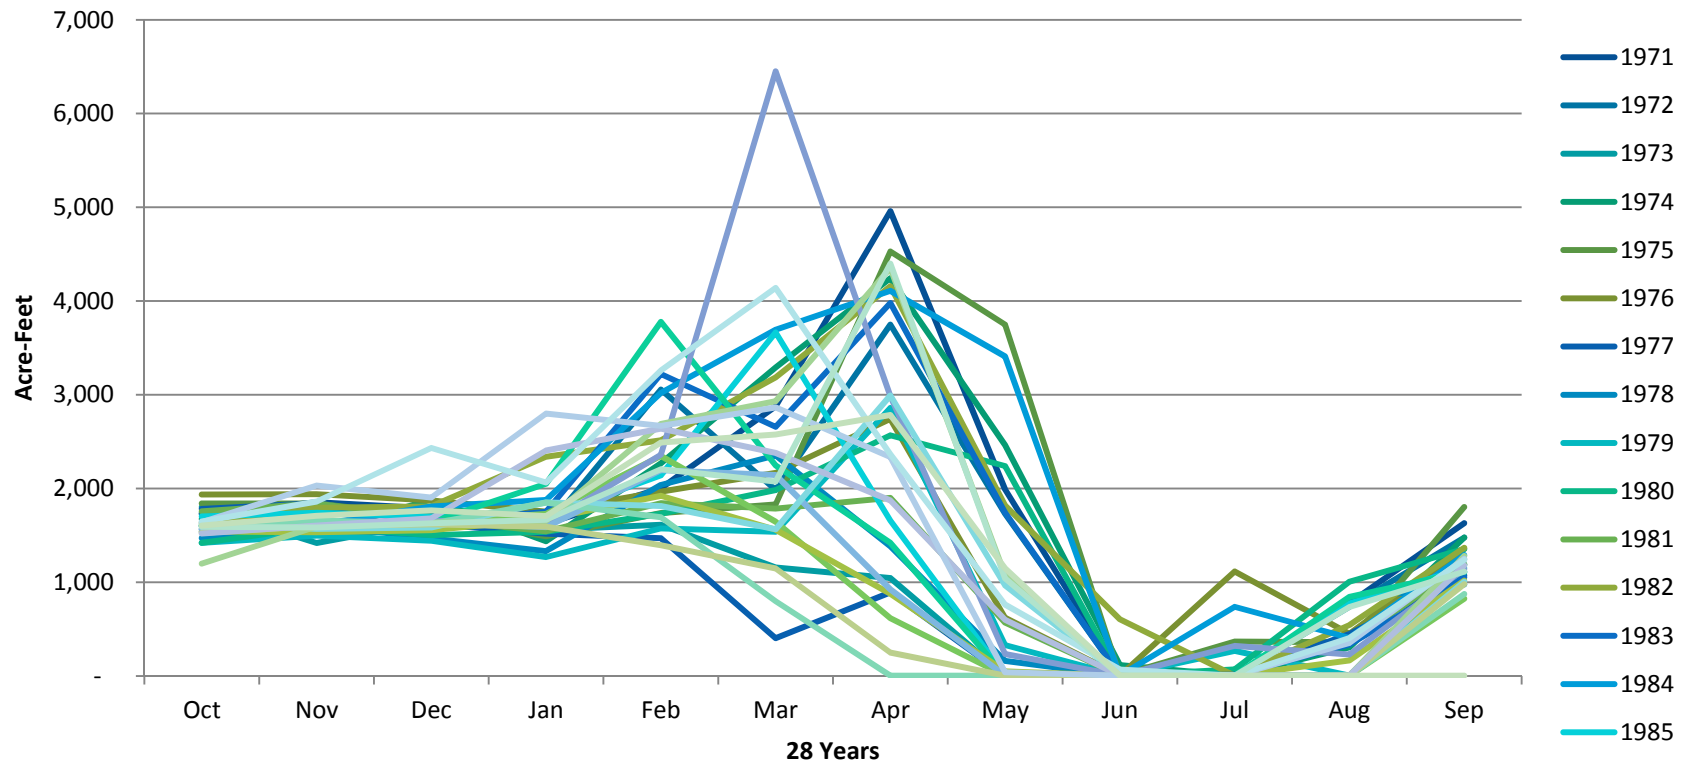
# Hydrograph In Upper Basin

**Hardman Reservoir Site  
Simulated Reservoir Inflow & Outflow - Existing Conditions**

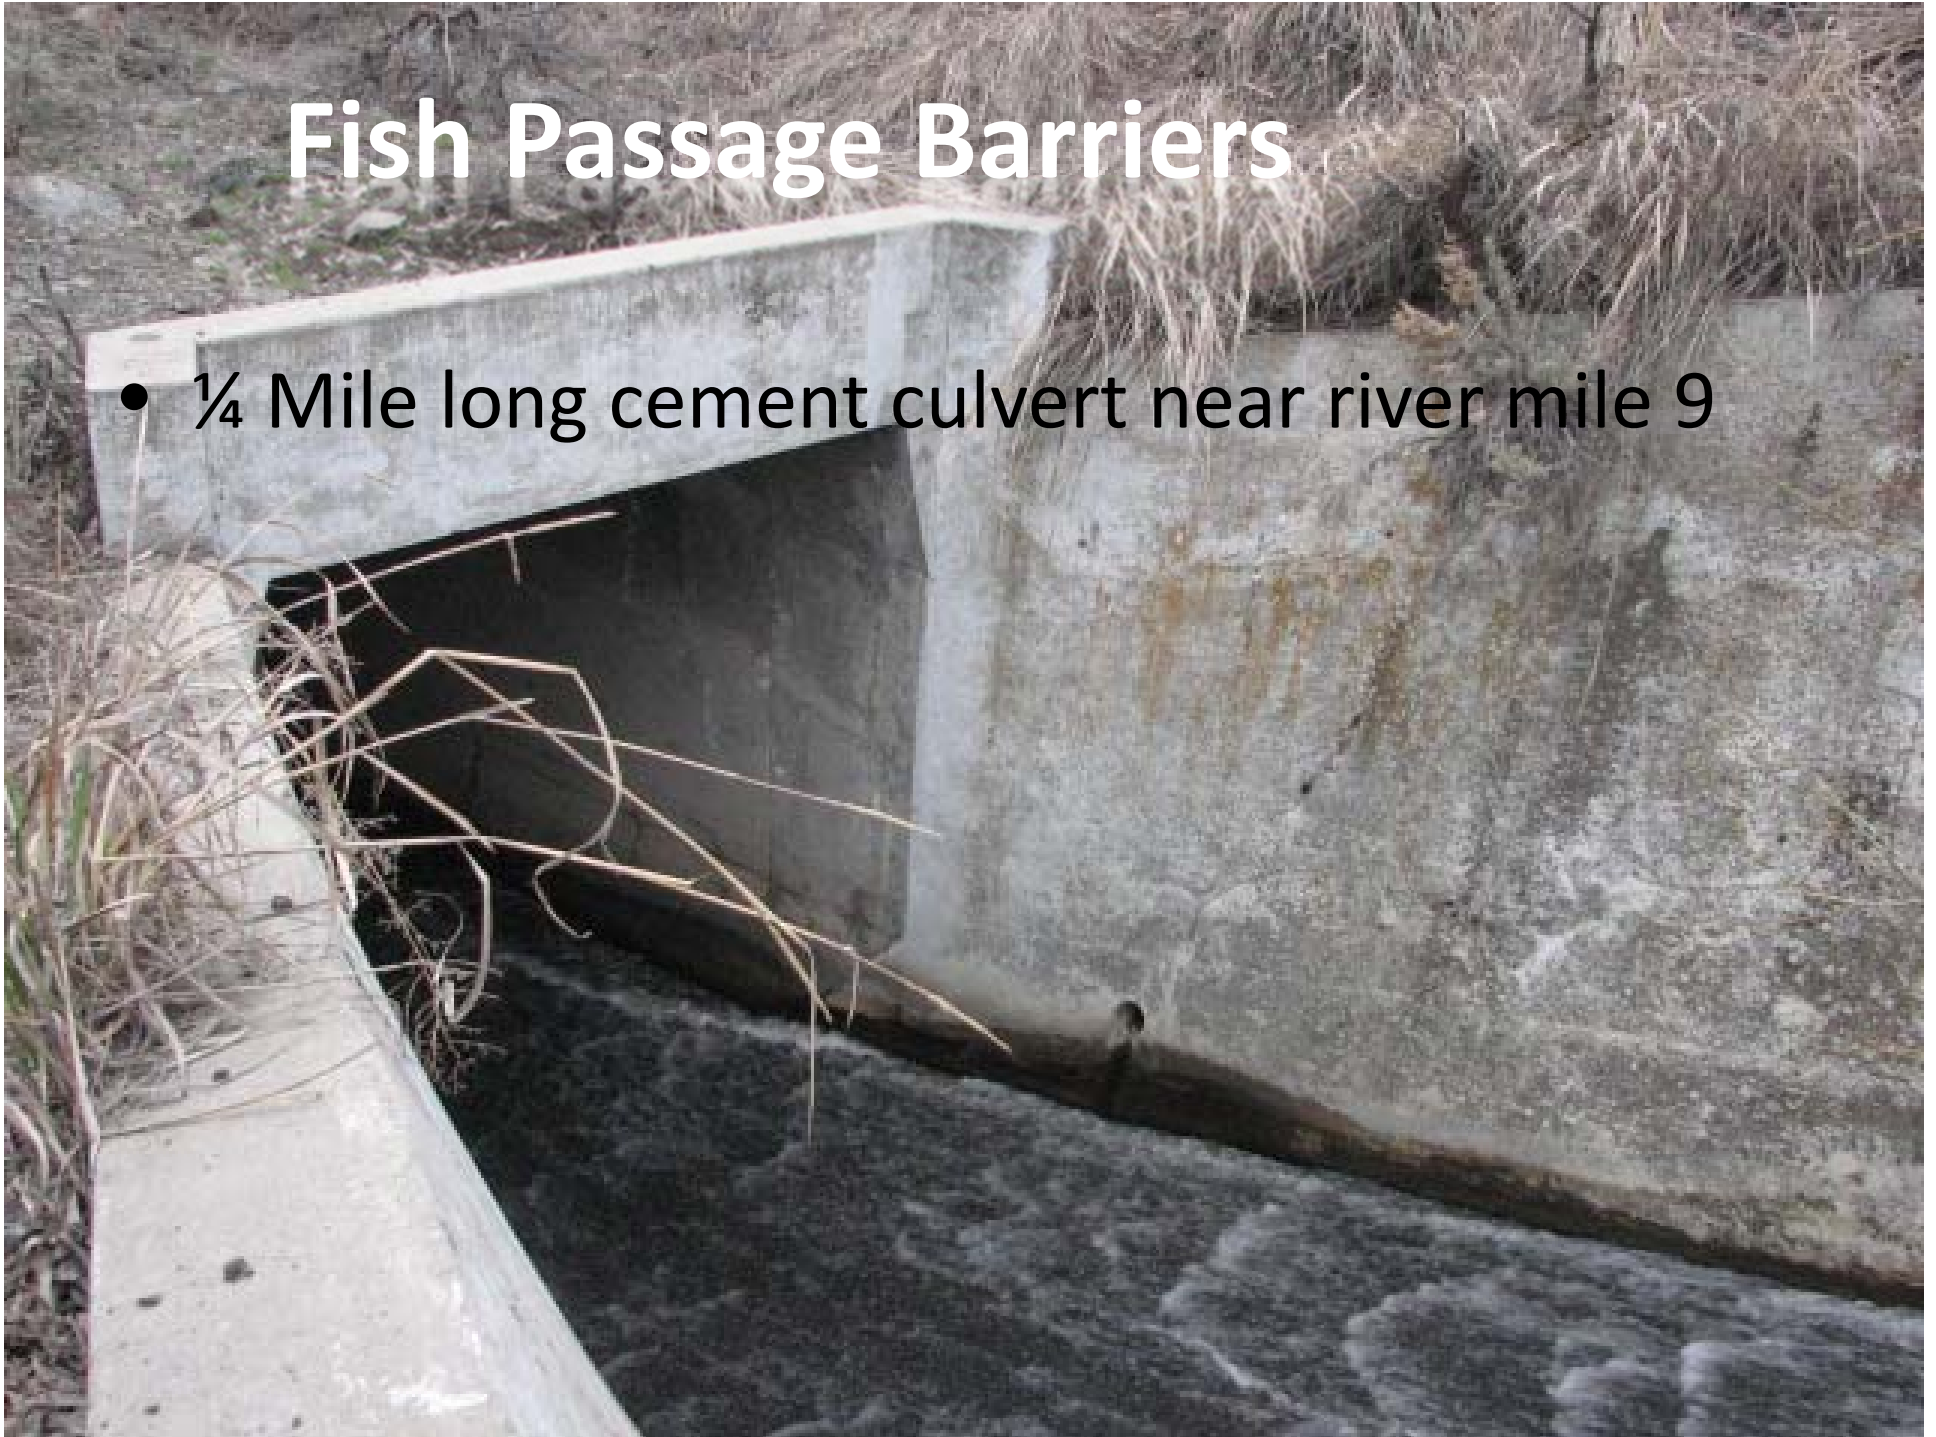
# Fish Passage Barriers

- ¼ Mile long cement culvert near river mile 9

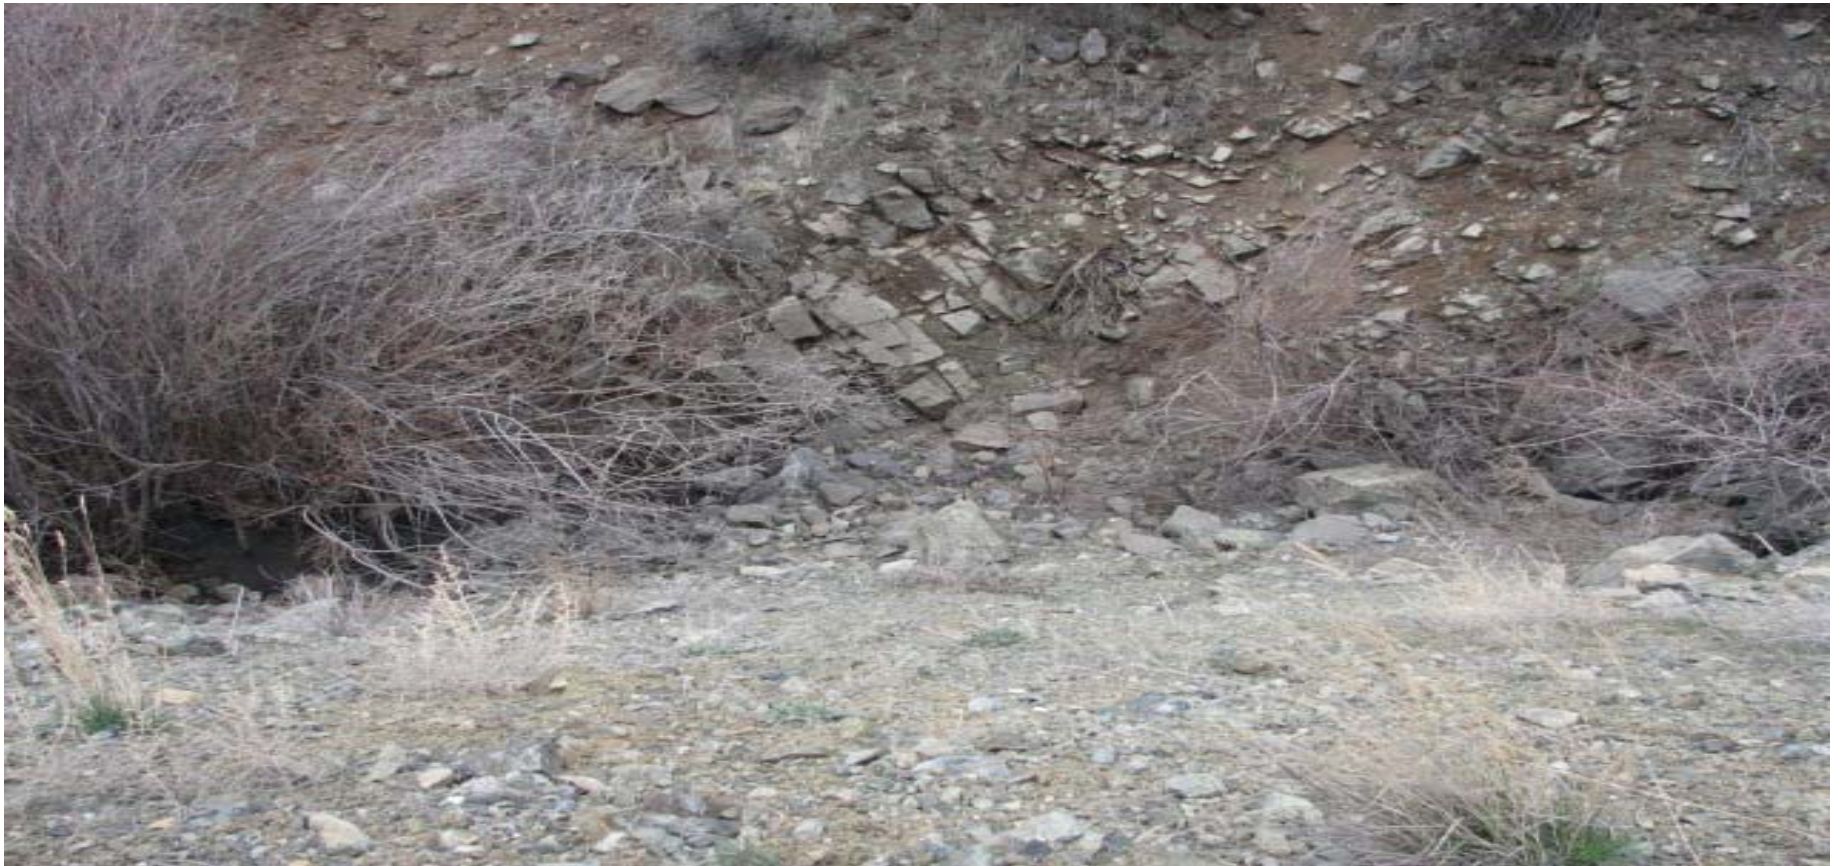
# Fish Passage Barrier

- Stream Goes Subsurface for  $\frac{1}{4}$  mile
