LARSON LUMBER COMPANY
PHILOMATH, OREGON

MILL LOG POND
Application No. 30743
30744
Permit No. 1868#24222

DES. GCM, DR. GCM, TR. CK CORNELL, HOWLAND, HAYES & MERRYFIELD CONSULTING ENGINEERS CORVALLIS, OREGON DWG. NO. C-1143-1

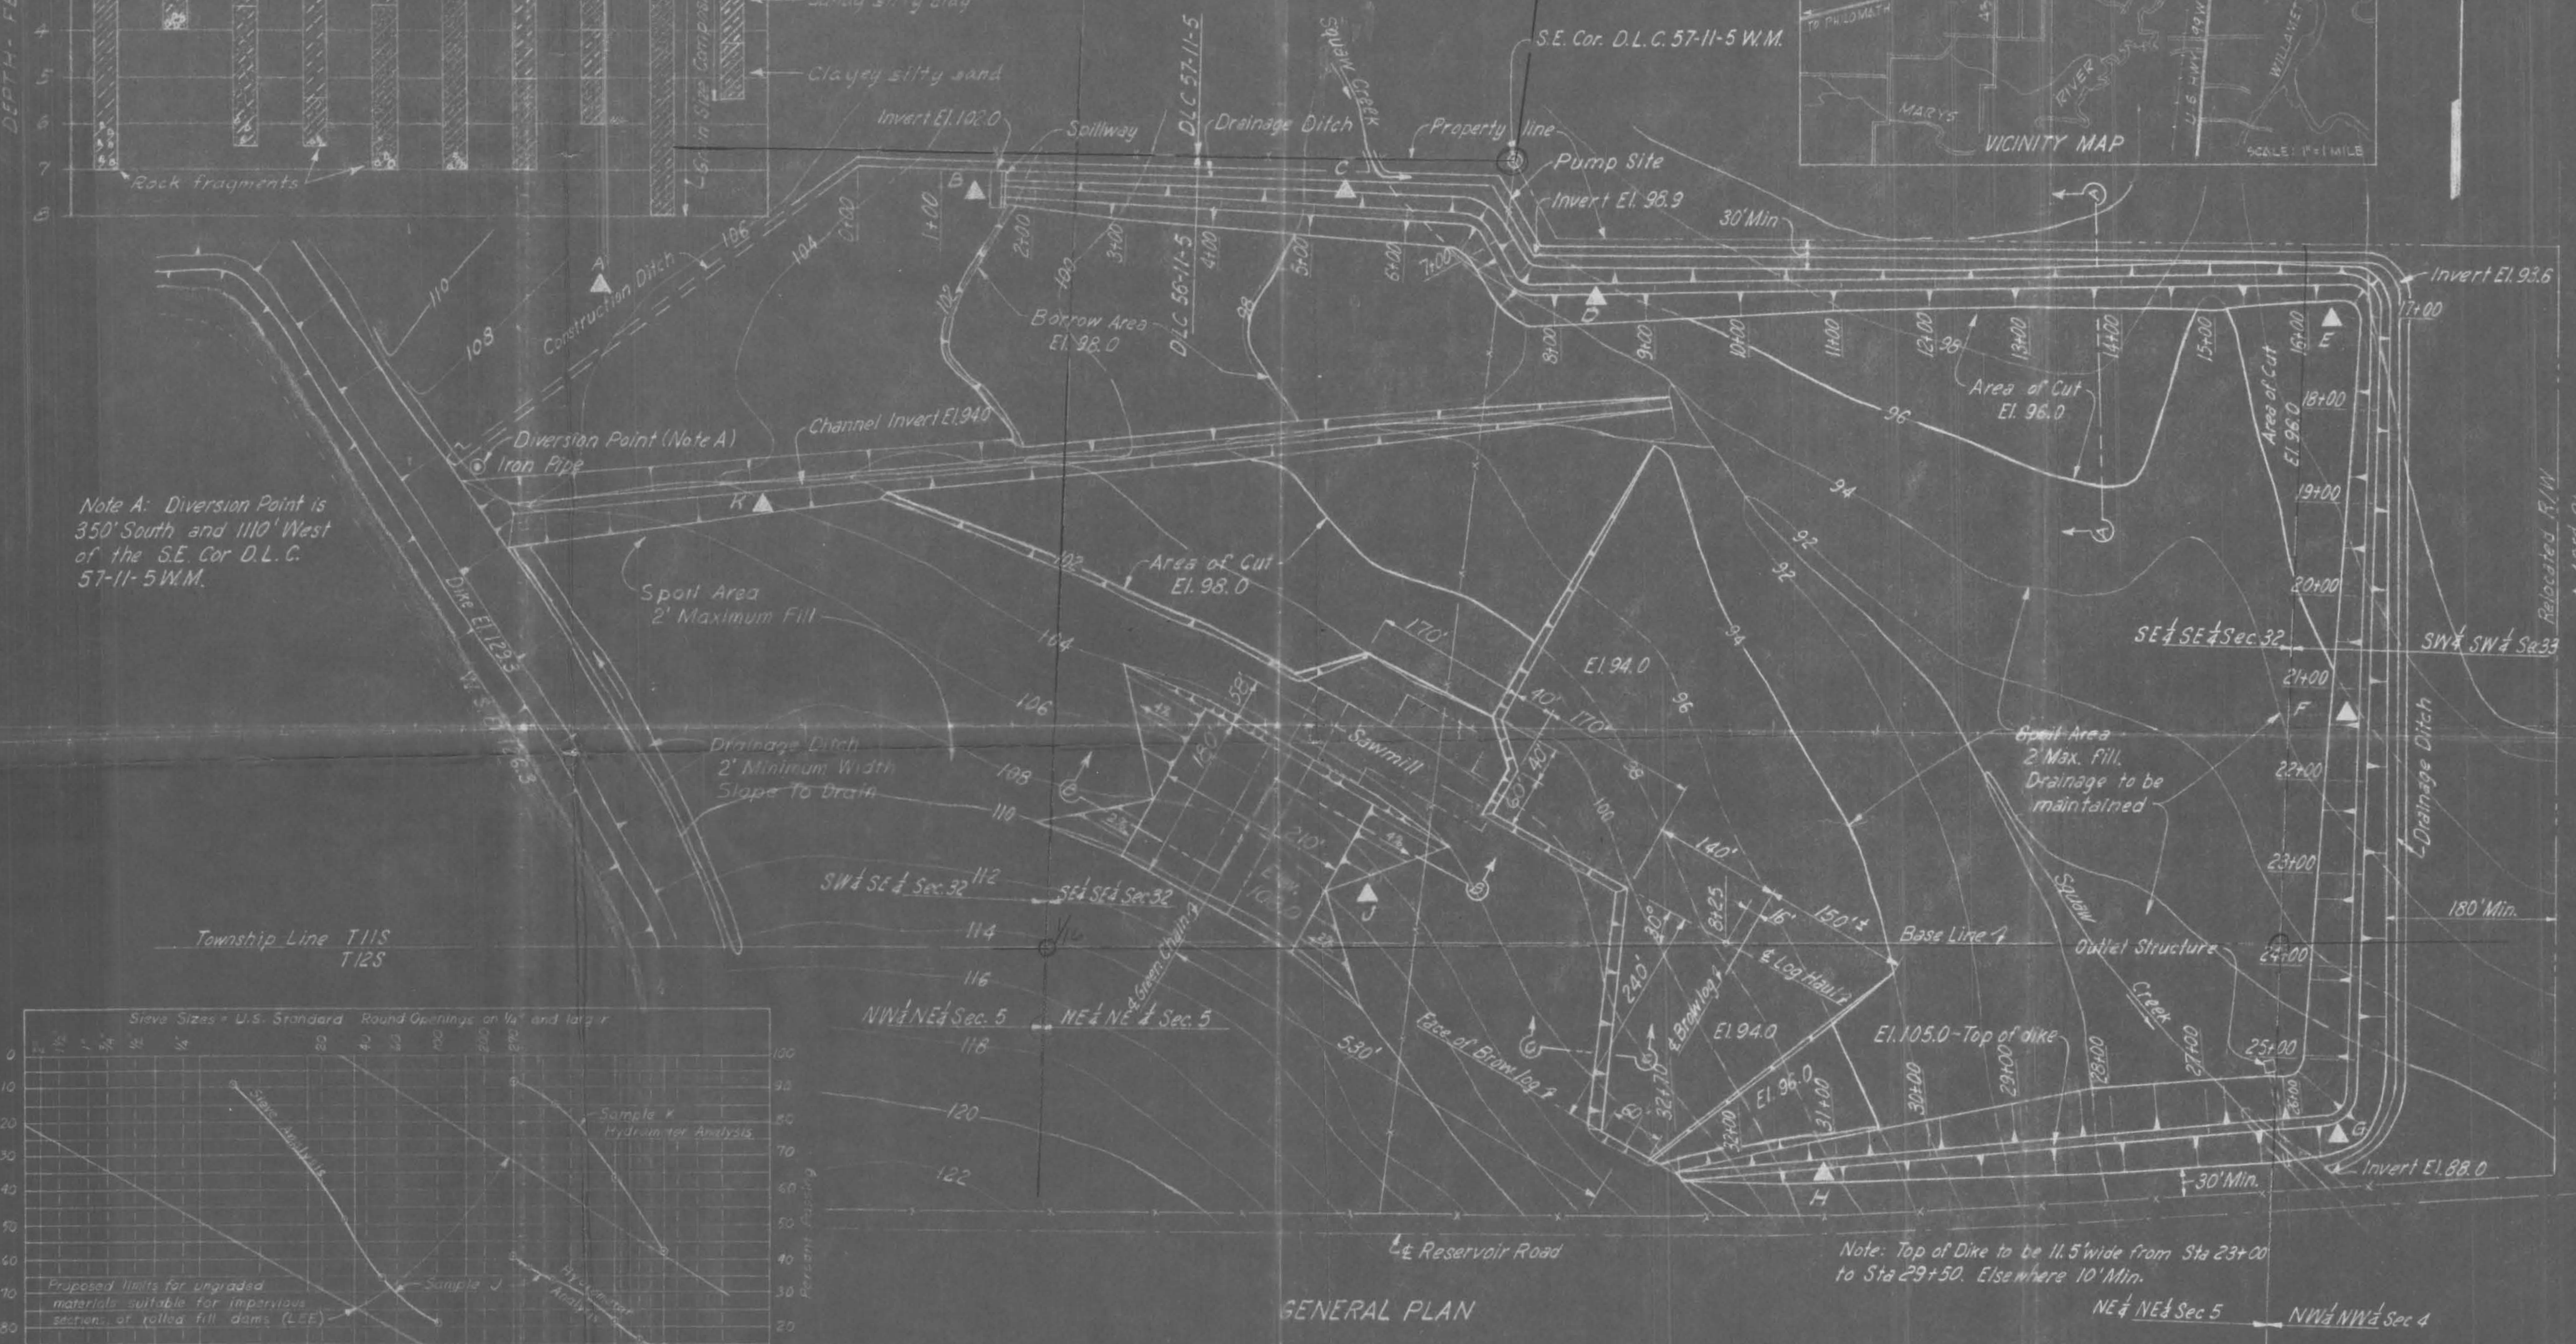
- Elevations shown are to assumed datum.
- Water surface elevation in log pond is 102.0
- ▲ = location hand auger hole

Note: Top of Dike to be 11.5' wide from Sta 23+00 to Sta 29+50. Elsewhere 10' Min.
