DRAWING NO. OR-03-9172.45-412

# AS BUILT MAP OF UNCLE DAN (58-4515) RESERVOIR

GOVT. LOT 3, SEC 34, T.9S., R.41E., W.M.  
U.S.G.S. QUAD - ENCINA, OREG. - 7 1/2'

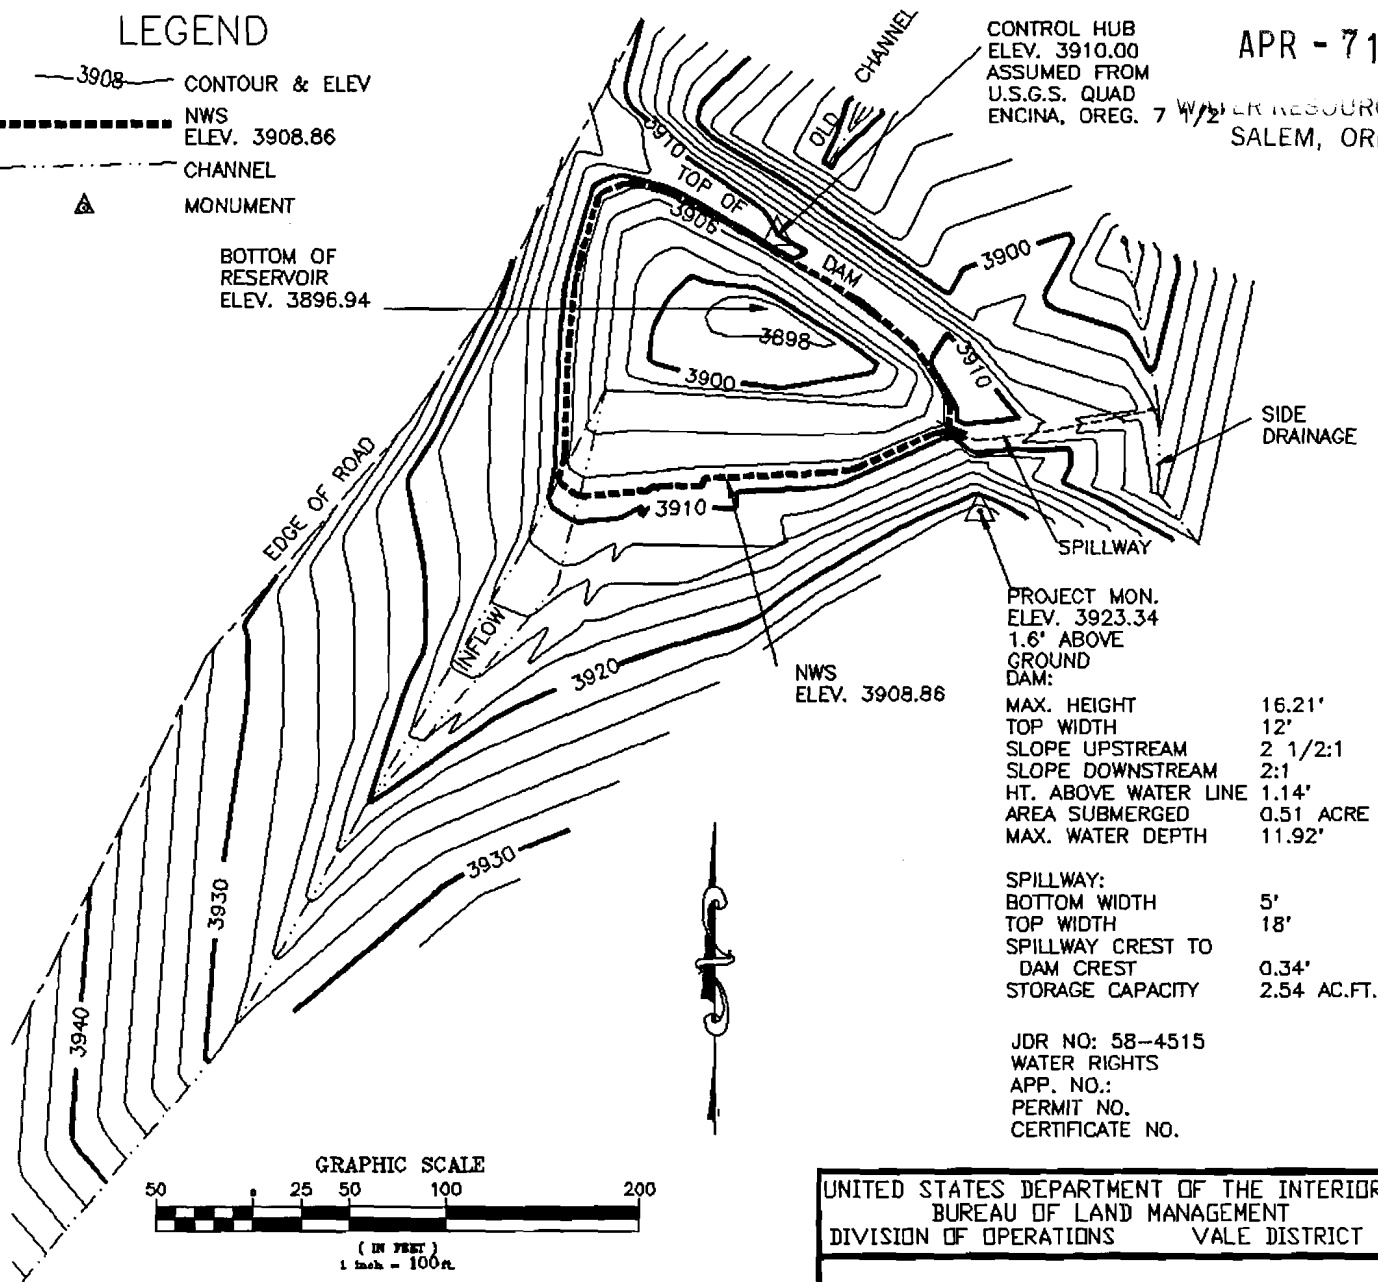
BOTTOM OF  
RESERVOIR  
ELEV. 3896.94

CONTOUR INTERVAL = 2 FEET

CONTROL HUB  
ELEV. 3910.00  
ASSUMED FROM  
U.S.G.S. QUAD  
ENCINA, OREG. 7 1/2'

PROJECT MON.  
ELEV. 3923.34  
1.6' ABOVE  
GROUND  
DAM:

FAILURE OF THIS STRUCTURE WOULD NOT POSE A THREAT  
TO LIFE OR PROPERTY.  
INSTALLATION OF AN OUTLET CONDUIT WOULD THREATEN  
THE INTEGRITY OF THE EXISTING STRUCTURE. SHOULD AN  
OUTLET CONDUIT BE REQUIRED LATER FOR WATER DISTRI-  
BUTION NEEDS, IT WILL BE INSTALLED USING APPROPRIATE  
SAFEGUARDS AND CONSTRUCTION TECHNIQUES, OR THE  
STRUCTURE MAY BE BREACHED OR RECONSTRUCTED.
