### Mosier Wells Repair / Replacement and Abandonment Project Summary

Kenneth E. Lite Jr. Oregon Water Resources Department

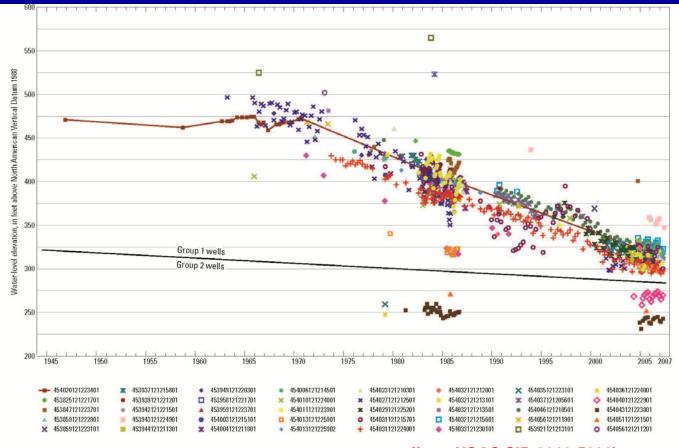
Figure 9. Water levels in selected wells in the Mosier, Oregon, study area, 1944–2008.

#### (from USGS SIR 2012-5002)

- Water level decline in wells
- Decreased streamflow in interconnected streams

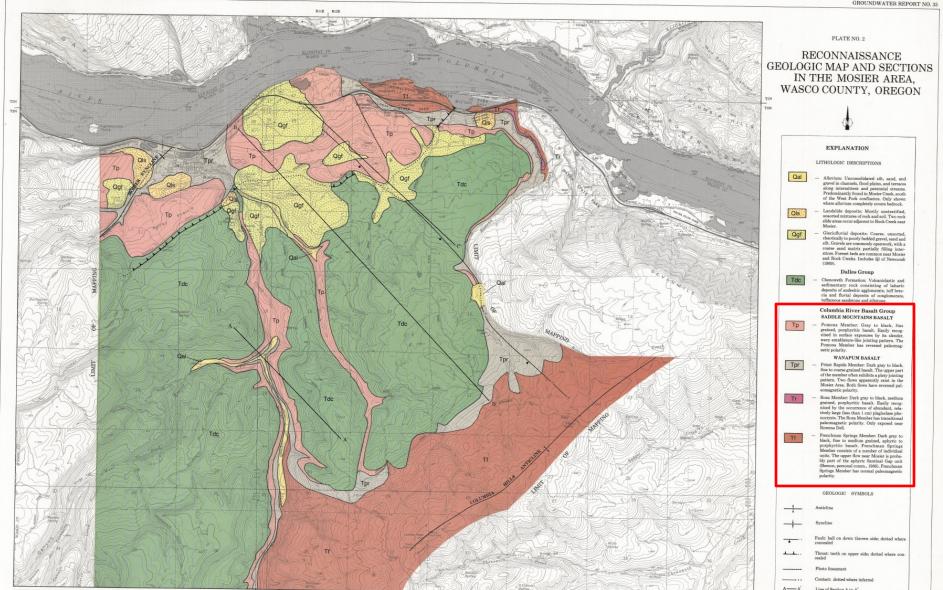
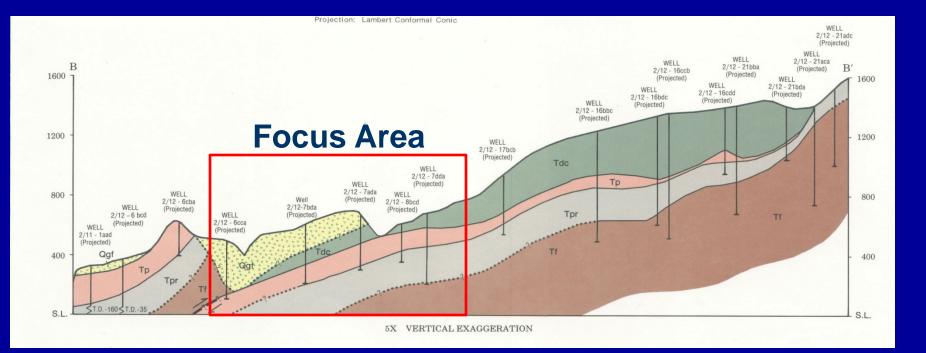
# Surface Geology near Mosier

#### STATE OF OREGON WATER RESOURCES DEPARTMENT (1988)

- Dalles Formation
- Pomona
- Selah interbed
- Priest Rapids
- Frenchman Springs
- Grande Ronde

Columbia > River Basalt Group

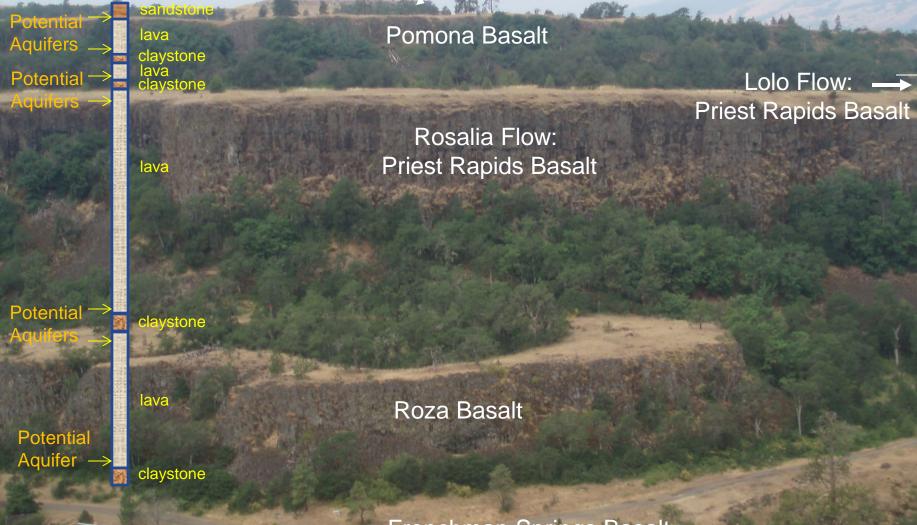
#### Hypothetical Well

**Dalles Formation**

Frenchman Springs Basalt

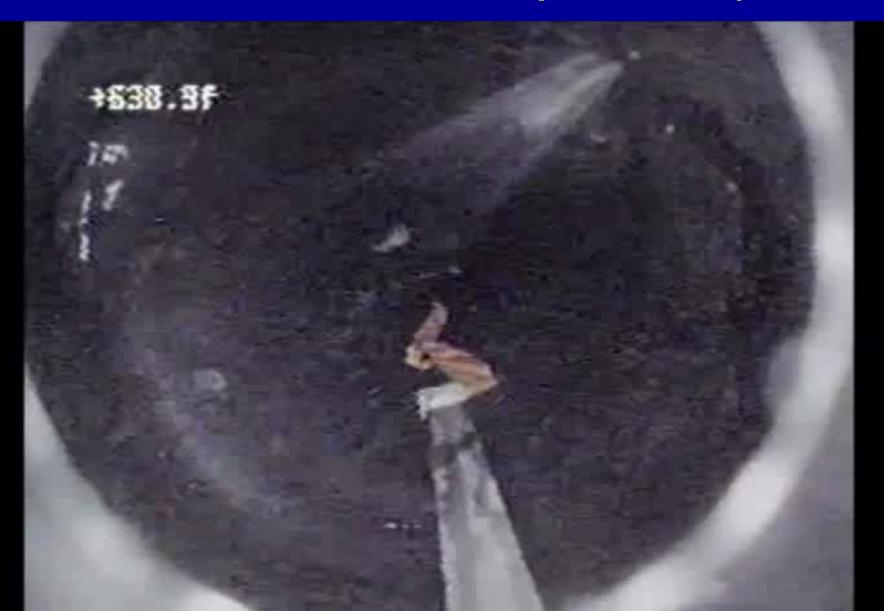
# Water jetting into a borehole wall (near the base of the Priest Rapids Basalt).

### Well Casing

Water moving up the space between the casing and the borehole wall.

**Claystone (Selah interbed)**

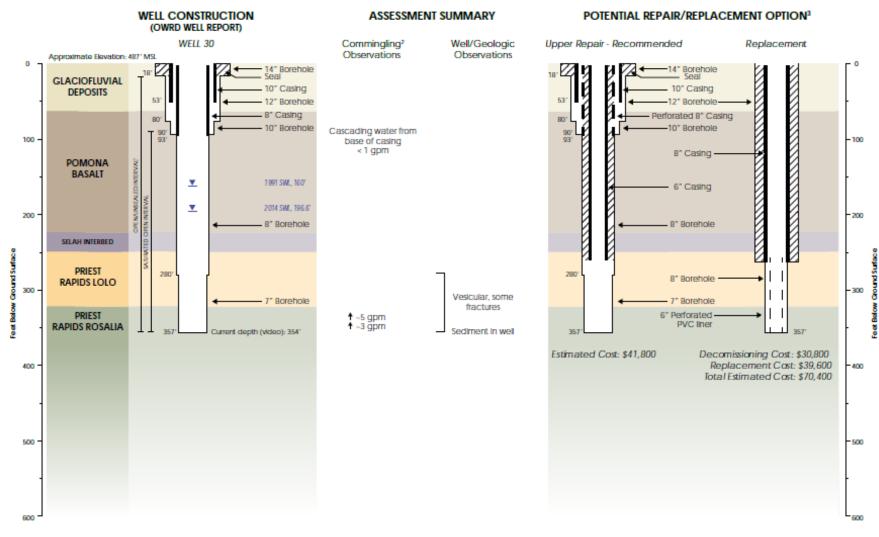
#### WELL ID: 30 ASSESSMENT COMPLETION DATE: March 26, 2014

#### SUMMARY INFORMATION:

Well is sealed into the Dalles Formation and cased into the Pomona Basalt. Open/unsealed in Dallas/Pomona/Priest Rapids. Movement of particulates observed in the well video indicates a small amount of upward movement from around 350 feet up to approximately 330 feet. Groundwater was also observed dripping into the borehole at the bottom of the casing (within the Pomona Basalt). Commingling pathway appears to be from the Priest Rapids into the Pomona Basalt aquifer. If pump diameter allows, attempt upper repair. Otherwise, replacement recommended for a well targeting the Priest Rapids Basalt aquifer.
