Transfer Application Map
 Move Point of Appropriation for GR-26/GR-22

Carlton Nursery Company, LLC
 Dayton\Currie Farm

Pacific Hydro-Geology Inc.

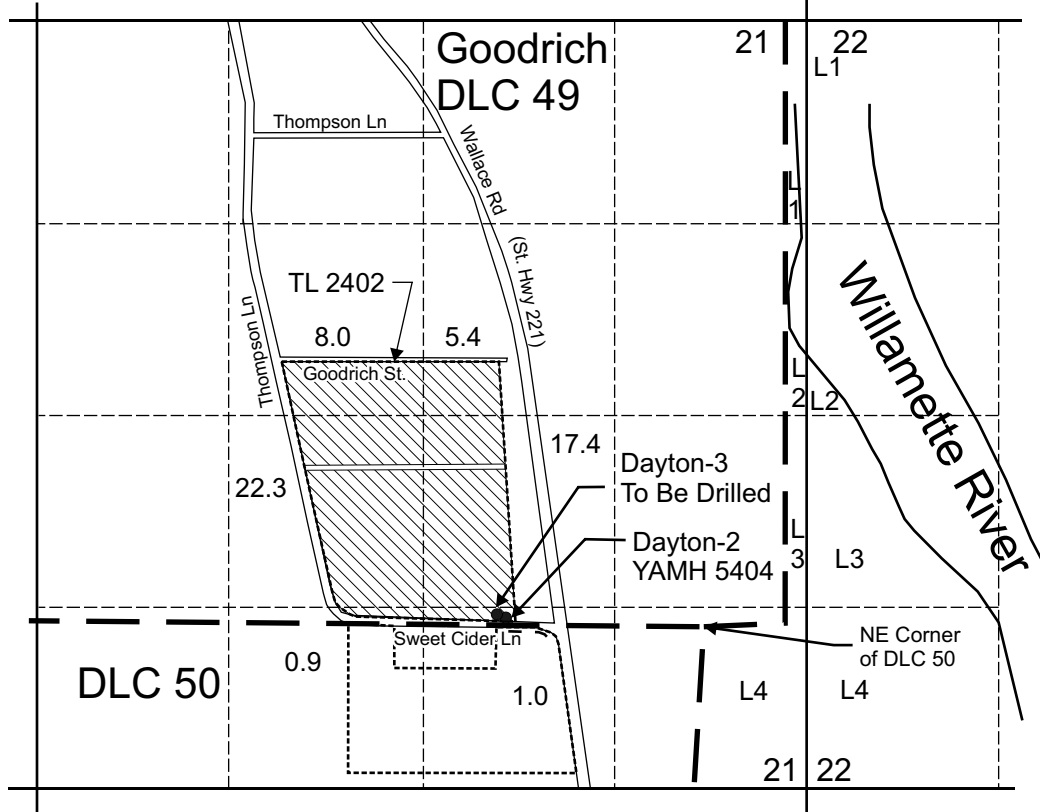
Existing Dayton-2 (YAMH 5404) is located 50 feet north and 1,440 feet west from the NE corner of DLC 50
 Dayton-3 (to be drilled) is located 75 feet north and 1,500 feet west from the NE corner of DLC 50

Area (55.0 Acres) irrigated under Registration GR-26, Certificate GR-22.

Note: The quarter quarter lines have been projected using a tax map, government land survey maps, an aerial photograph, and best professional judgement.
